SAFETY EFFECTS OF COMBINED ROAD ALIGNMENT ON DRIVERS' PERCEPTION ERRORS

ROSEMARY NYAMWERA
ROBERT GALATIYA SUYA
CHARLES KAPACHIKA
SAMSON MAZONDE BANDA
EMMANUEL MWAMATOPE
FABIANO M'NDALA

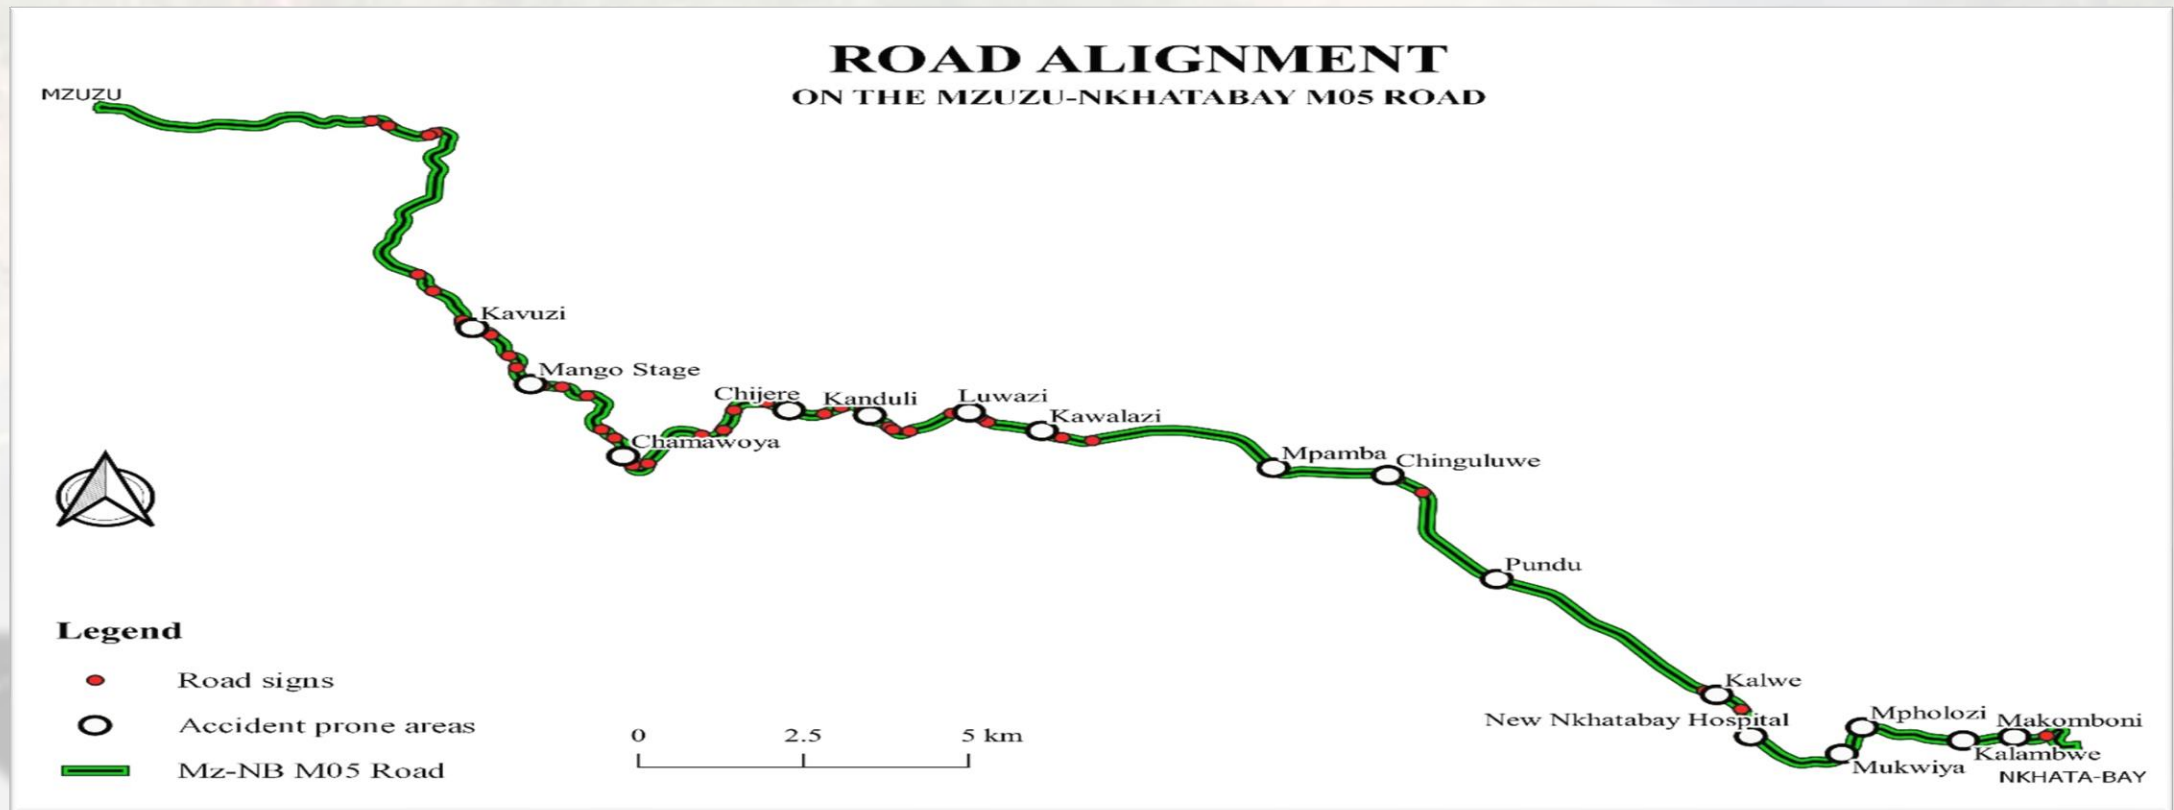
- The analysis of the secondary data from RA was used to visualise the road alignment and direct observations shows that efforts were made during the rehabilitation to avoid sharp curves

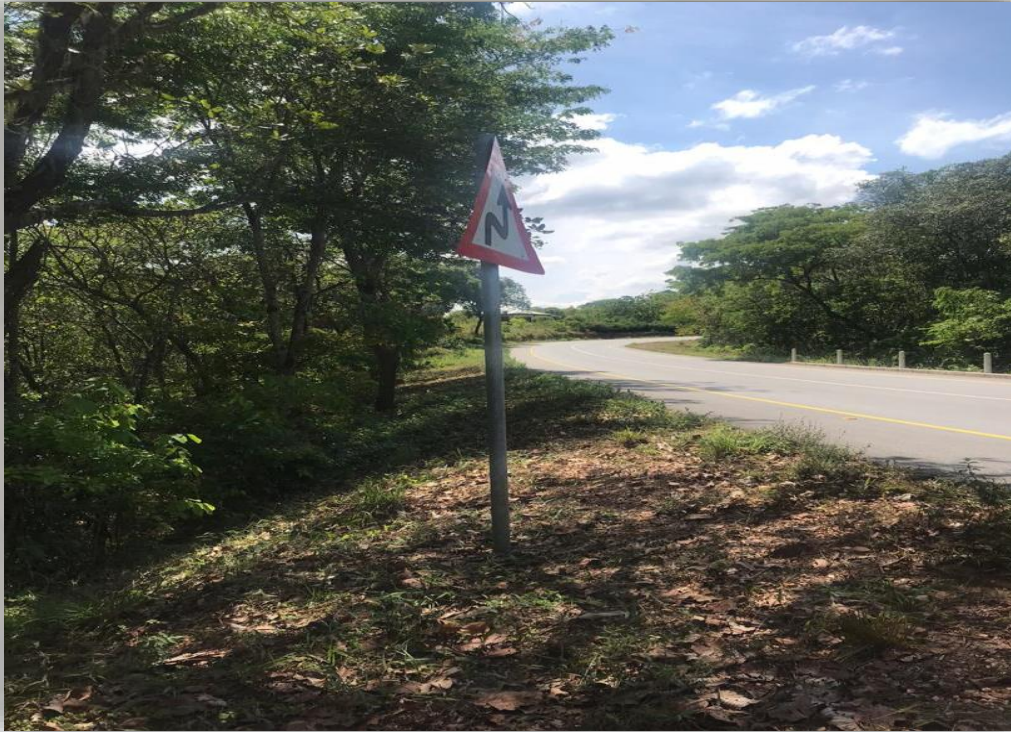
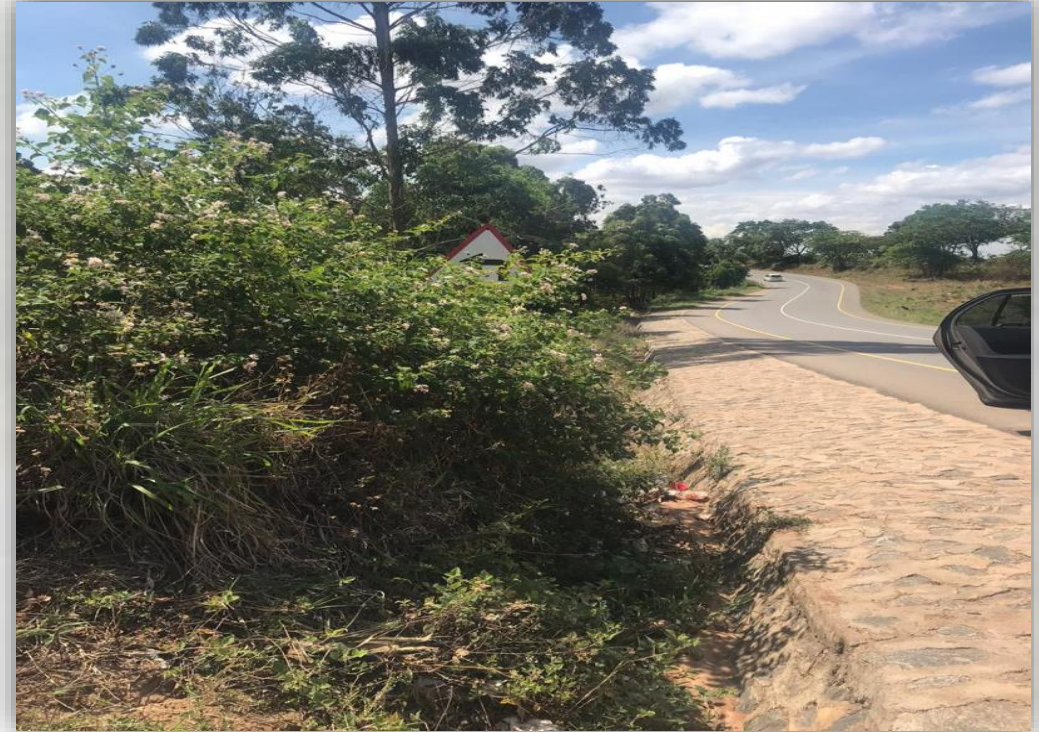
- It was also observed that despite most road signs having been omitted, some road signs are obscured by vegetation and poorly positioned

- These results concur with the findings of Isabel *et al* (2016) who also concluded that when road signs are poorly positioned and not in adequate numbers, drivers' perception errors increase, hence reducing their safety as they travel on the road.
